## **Preliminary Report**

**Accident involving Air India's B787-8 aircraft bearing registration VT-ANB  
at Ahmedabad on 12 June 2025**

**Government of India  
Ministry of Civil Aviation  
Aircraft Accident Investigation Bureau**

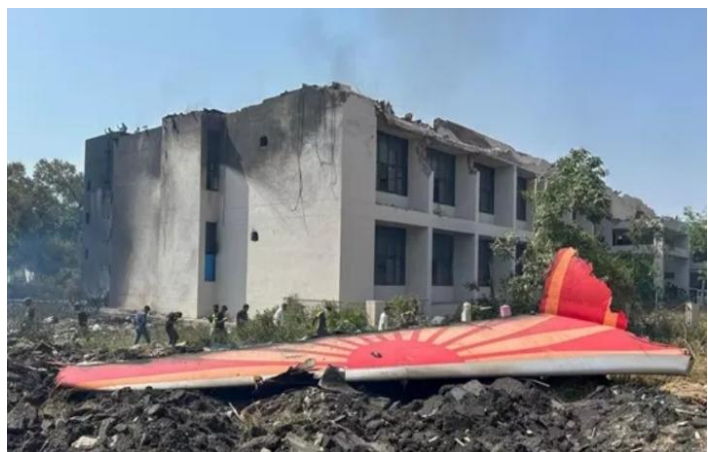
Figure 5 Vertical Stabilizer adjacent to Building A

The vertical stabilizer (*fig. 5*) separated from the aft fuselage and came to rest about 200 feet south of the initial point of contact with the Building A. The tail section and the RH Main Landing Gear (MLG) of the aircraft were found embedded in the northeast wall of the Building A while the rest of the airplane continued its forward movement.

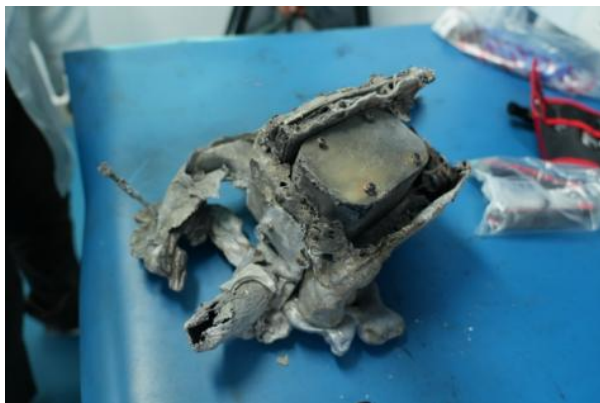
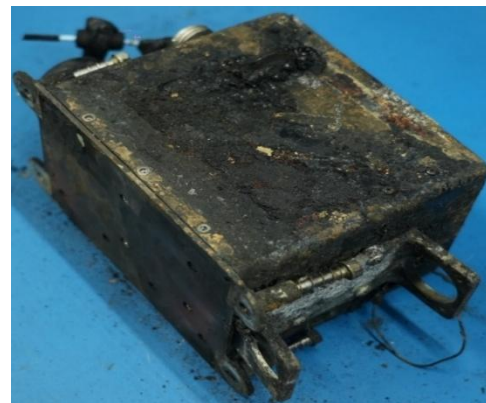
Figure 14 EAFR AFT & FWD

The aft EAFR was located on the roof top of Building A on 13<sup>th</sup> June 2025. The EAFR had impact and thermal damages to the housing. The wires were protruding from the housing and the connectors were burnt.

The forward EAFR was located on 16<sup>th</sup> June 2025 from the wreckage debris besides the Building F. The EAFR was burnt and covered in soot. The EAFR was still attached to the

equipment shelf with part of the connector melted but still connected. The ULB was still connected to the housing and the lithium battery was also attached to the equipment shelf, which was removed later prior to transportation.

The aft EAFR was substantially damaged and could not be downloaded through conventional means. The CPM was opened to inspect the memory card. The damage was extensive.
